# EFFECTS OF REPLACEMENT OF A DYNAMIC CRASH TEST WITH A QUASI DYNAMIC ONE. TEST OF PW-5 WORLD CLASS GLIDER

by Piotr Czarnocki, Tadeusz Wiacek, Waldemar Wingralek, Warsaw University of Technology

*Presented at the ICAS 21st Congress, Sorrento, Italy*

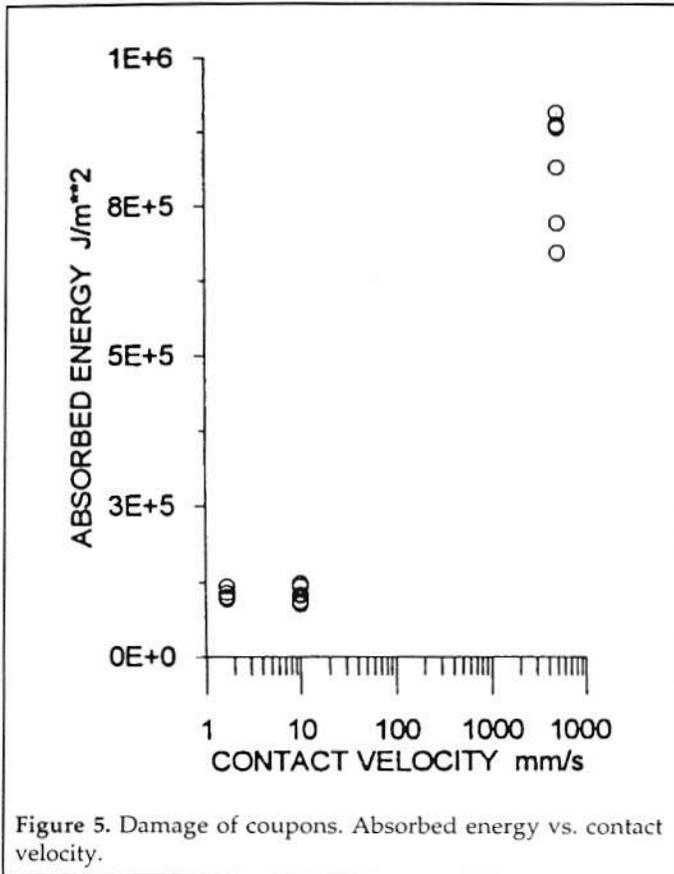
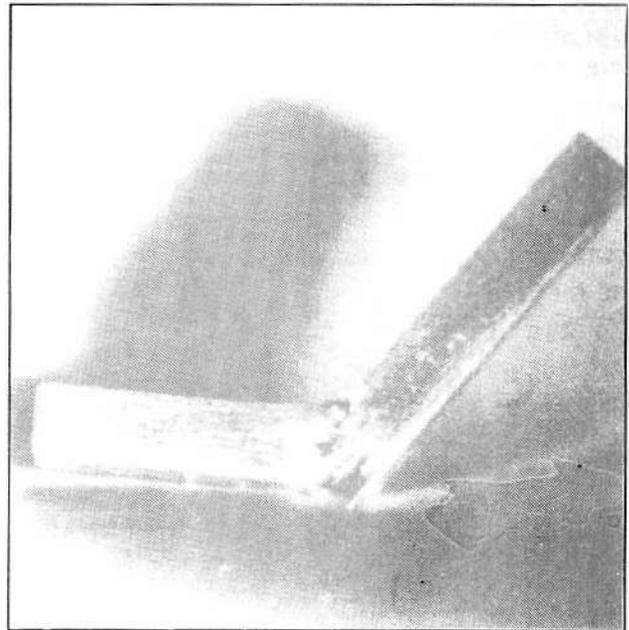
Figure 7. Damage caused by static loading. Contact velocity 1.67 mm/s.

The diagram in Figure 5 indicates that the amount of energy absorbed during low velocity loading (1.67 mm/s and 10 mm/s) is about eight times lower than that absorbed during high velocity loading (5000 mm/s). The coupons failed under static loading display relatively small damage zone, Figure 7. It is localized in the close vicinity of the fracture and is restricted to fibers and matrix broken in tension or compression. In this case the main mechanism of energy absorption is rupture of fibers and matrix, and pull

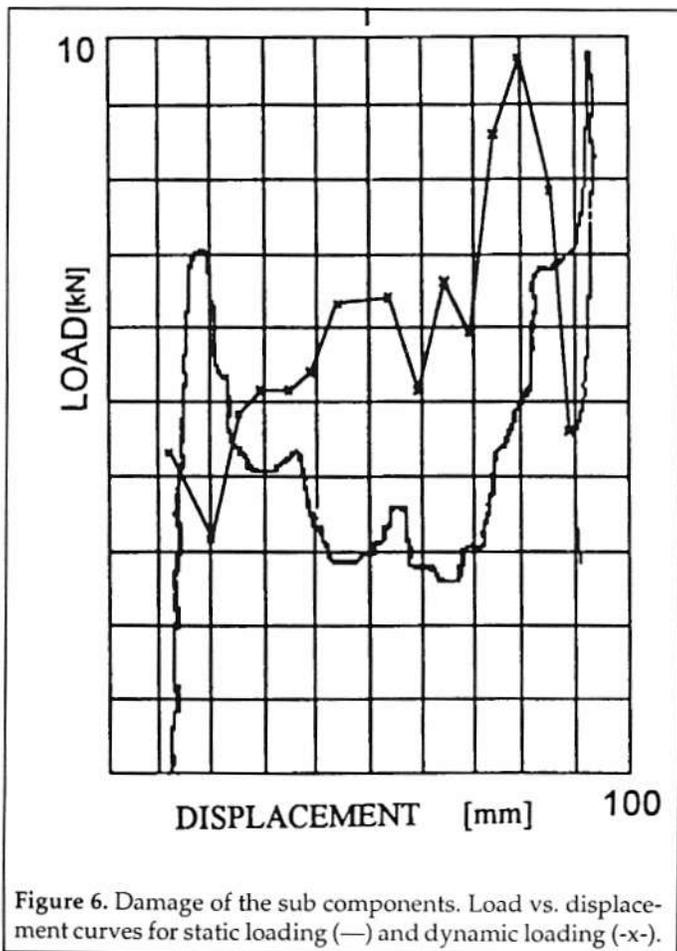
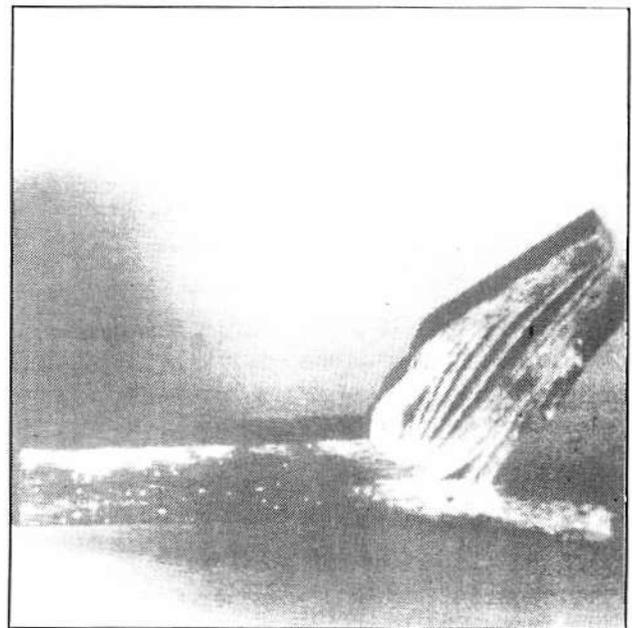
Figure 8. Damage caused by dynamic loading. Contact velocity 5000 mm/s.

out of fibers. Contribution of delamination is small. The damage caused by the dynamic loading is more complex. The picture in Figure 8 suggest that the observed extensive delamination is the main mechanism of energy absorption. The reason for which almost no delamination is produced by static loading is not well known and further material investigations are needed.

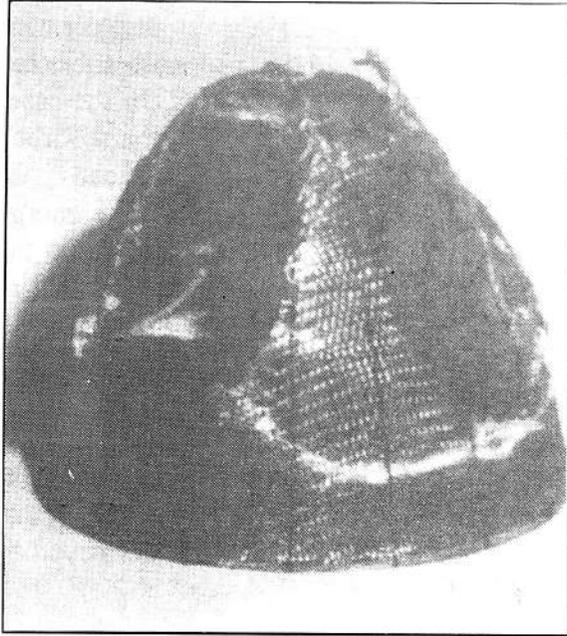
**Figure 9.** Damage caused by static loading. Contact velocity 1.5 mm/s.

In the case of the sub components the observed modes of failure in a macro scale are similar. In the both cases initially the shell locally buckled then collapsed inward. The amount of the absorbed energy corresponding to the

static loading was about 40% lower than that corresponding to the dynamic one. Inspection of the damaged test piece' suggests that the static loading produces branched, throughout cracks resulting from local bending. The damage of the composite shell is restricted to the areas in the nearest vicinity of the cracks, Figure 9. Under dynamic loading, cracks are less extensive but accompanied with extensive delaminations, Figure 10. Probably, the splitting of layers reduces stiffness of the shell and the value of the normal stresses resulting from the local bending is not high enough to break the fibers and the delamination is the main mechanism of the energy absorption.

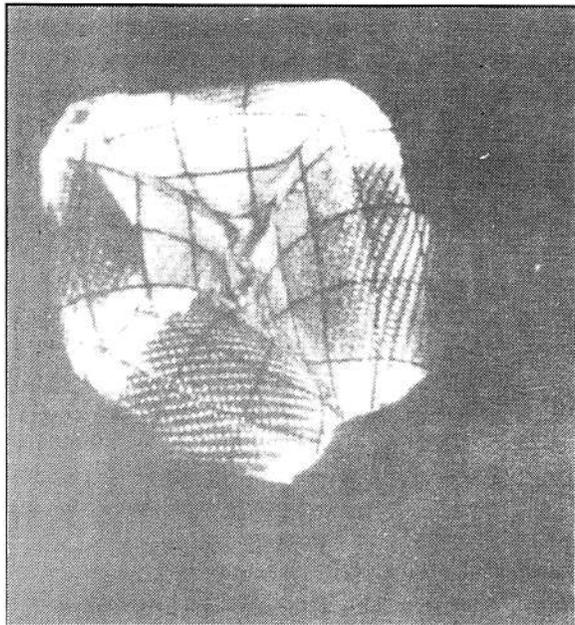
**Figure 10.** Damage caused by dynamic loading. Contact velocity 11.3 m/s.
