# Experimental Study of Impact Phenomena in the case of a Composite Glider

Lukasz Lindstedt, Miroslaw Rodzewicz, Cezary Rzymkowski and Krzysztof Kedzior  
Warsaw University of Technology, Institute of Aeronautics and Applied Mechanics  
Nowowiejska 24, 00-665 Warsaw, Poland  
luclin@meil.pw.edu.pl

Presented at the XXIX OSTIV Congress, Lüsse-Berlin, Germany, 6 - 13 August 2008

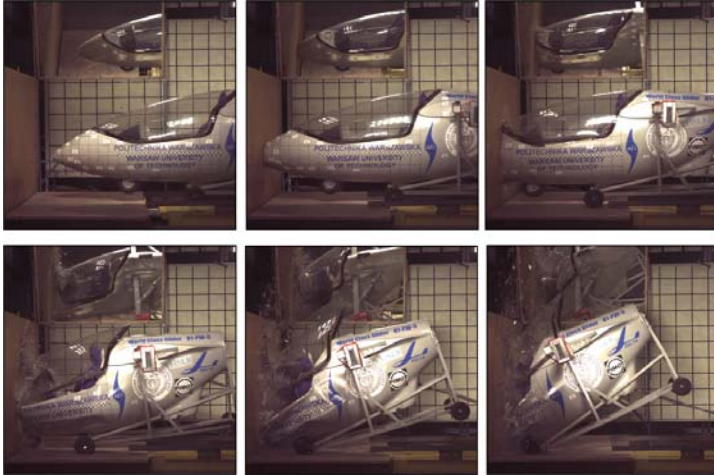
**Figure 6** Selected movie frames illustrating the course of test two ( $\Delta t = 10$  ms).

In the course of test, one can distinguish two stages. The first stage is the time between the moment when glider hit the rigid wall barrier ( $t = 0.067s$  after starting the registration) and the time when the cockpit starts to rotate ( $t = 0.095s$ ) (Fig. 6). During this phase of the crash, one can observe the rapidly increasing structure deformation which led to damage of the frontal part of the cockpit. The structure was heavily damaged. From the experiment point of view, this 30ms is decisive. After this time (the motion of the failed structure), registration of

In the course of the examinations, complete damage of nose cone, cockpit sill and frontal part of the fuselage were observed. This means that the structure of the cockpit failed under the imposed loads.

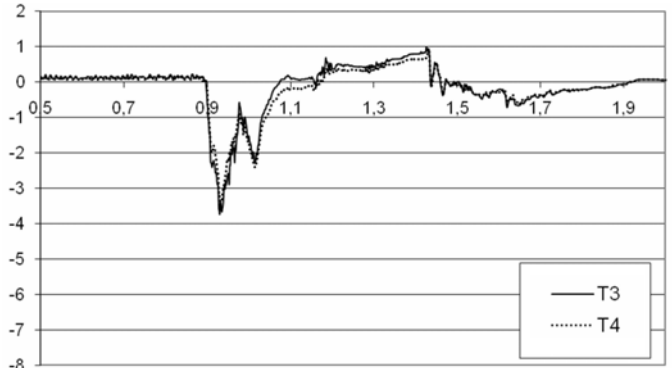
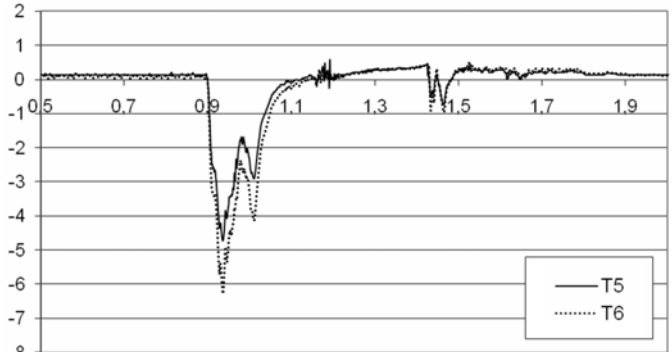
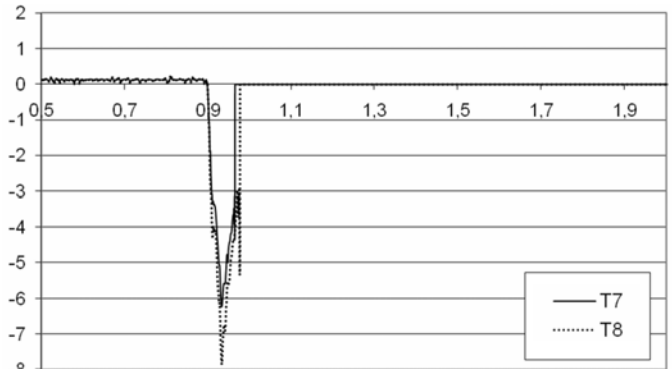
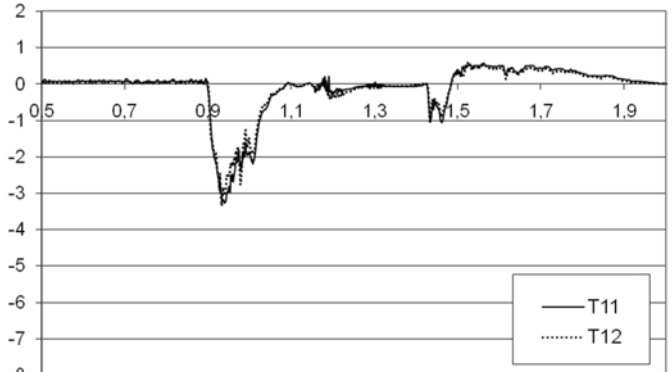
**Figure 8** Time histories of strain at chosen points (shown in Fig 1) of the cockpit. Cables from sensors T7 and T8 were broken at 0.97s but the maximum strains were recorded earlier.

- maximum acceleration of the glider mass centre:  $21.4g$  in the moving direction and  $12.5g$  in the vertical direction,
- maximum accelerations under the pilot seat:  $23g$  and  $15g$ , respectively,
- deformations observed on the cockpit side at two points slightly exceeded 6% (operational limit)

and at one point reached 8‰ (close to strength limit).

Figure 8 shows the time history of the strain at the cockpit sill point subjected to the highest load.

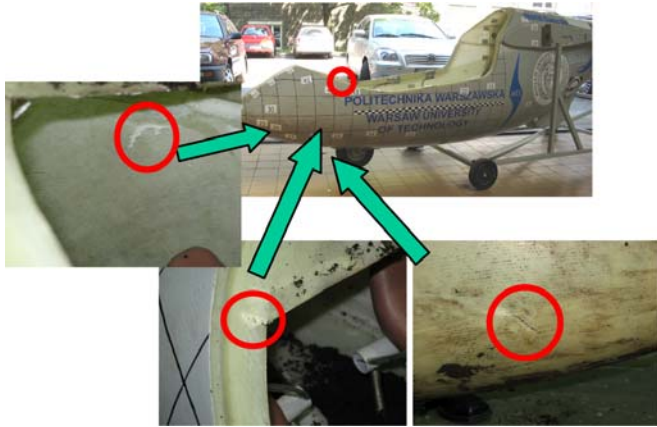
**Figure 9** Small cracks observed after the first crash test.

There was no serious damage observed. Nevertheless, at a few points, small cracks appeared (see Fig. 9).

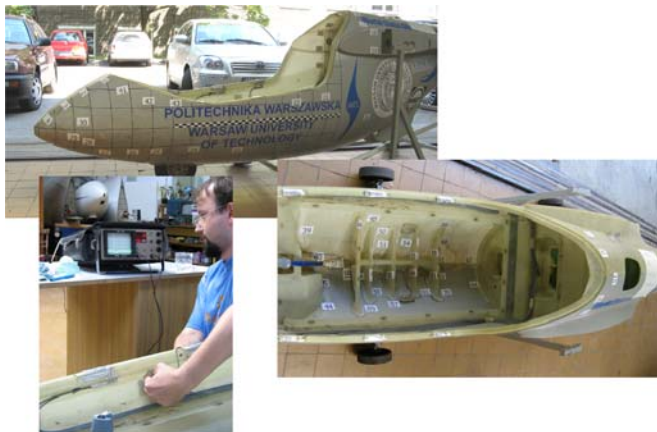
**Figure 10** Locations of selected examination points.

After cleaning the glider cockpit of soil and dust, the structure was examined using the ultrasonographic method. The main aim of the examination was to check all places and points on the surface which could not be examined by simple visual assessment but could be damaged (e.g. thick layers of glued joints). The simplified ultrasonographic method (Y/N) was used (Fig. 10). Based on expert opinions, about 100 points were selected for close examination.

In the course of the examination, no serious faults were observed. This means, that the structure of cockpit at selected points withstood the imposed loads.

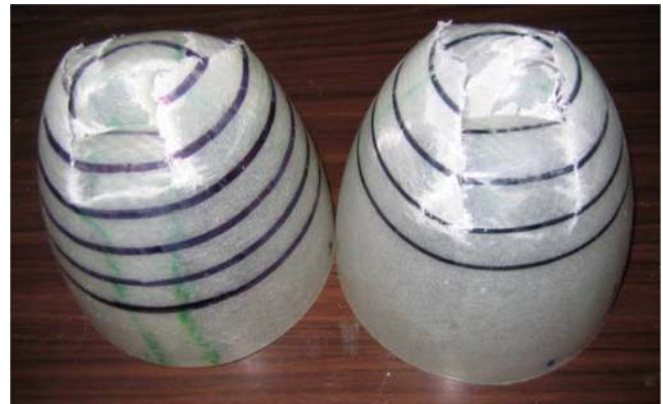
**Figure 13** Specimens after impact.

the overlaps at the nose cone) of a glass fabric (300 g/m<sup>2</sup>) and epoxy resin (0.36 vol. fraction). The cones were fixed into the ring-fastening which was positioned at the end of a pendulum arm together with the adjustable weights. The angle of pendulum and the signal from accelerometer placed in the centre of the cone-fastening were recorded. On this basis, we estimated the energy of impact and its dissipation. The signal from the accelerometer allowed calculation of the impact force. An example of results obtained from the experiments is shown in Fig. 12. The specimens after impact are shown in Fig. 13.
