The Rotunda

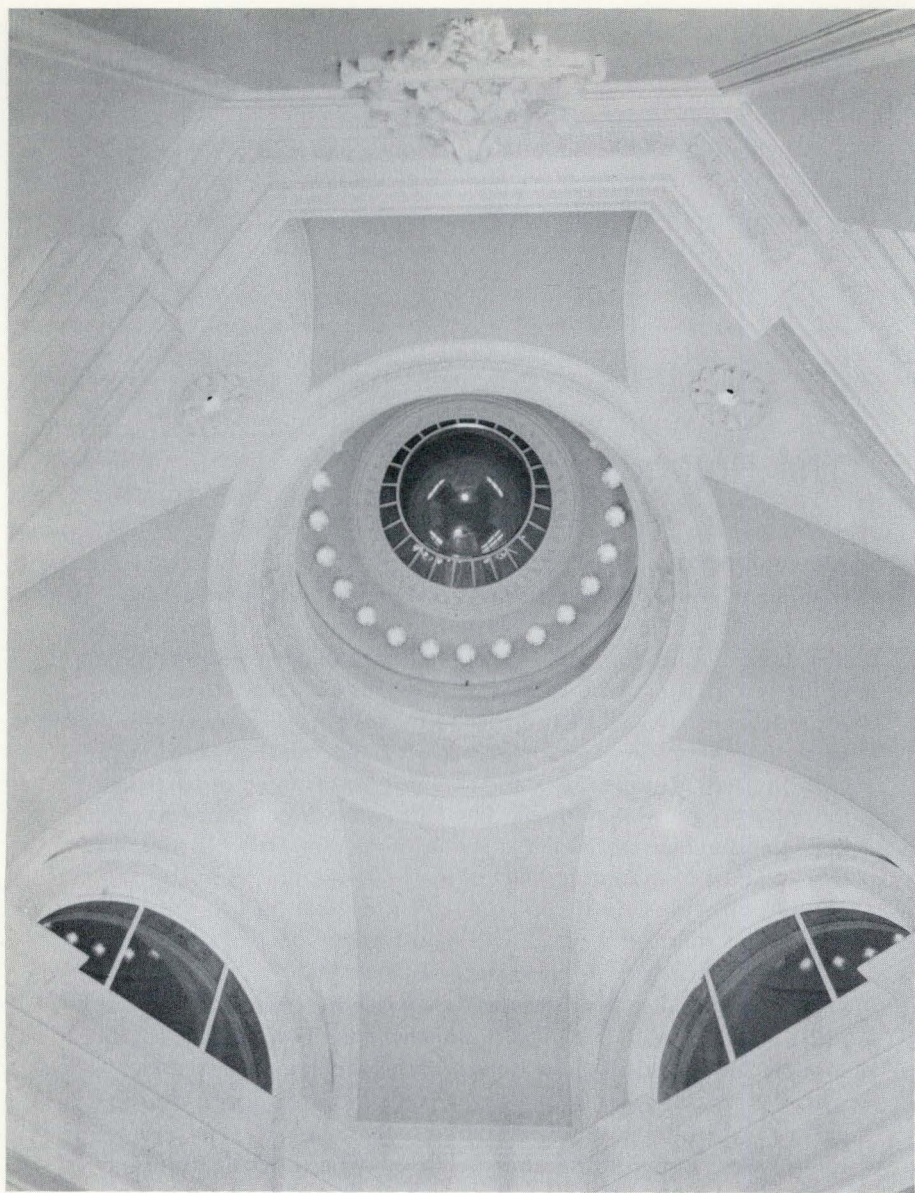
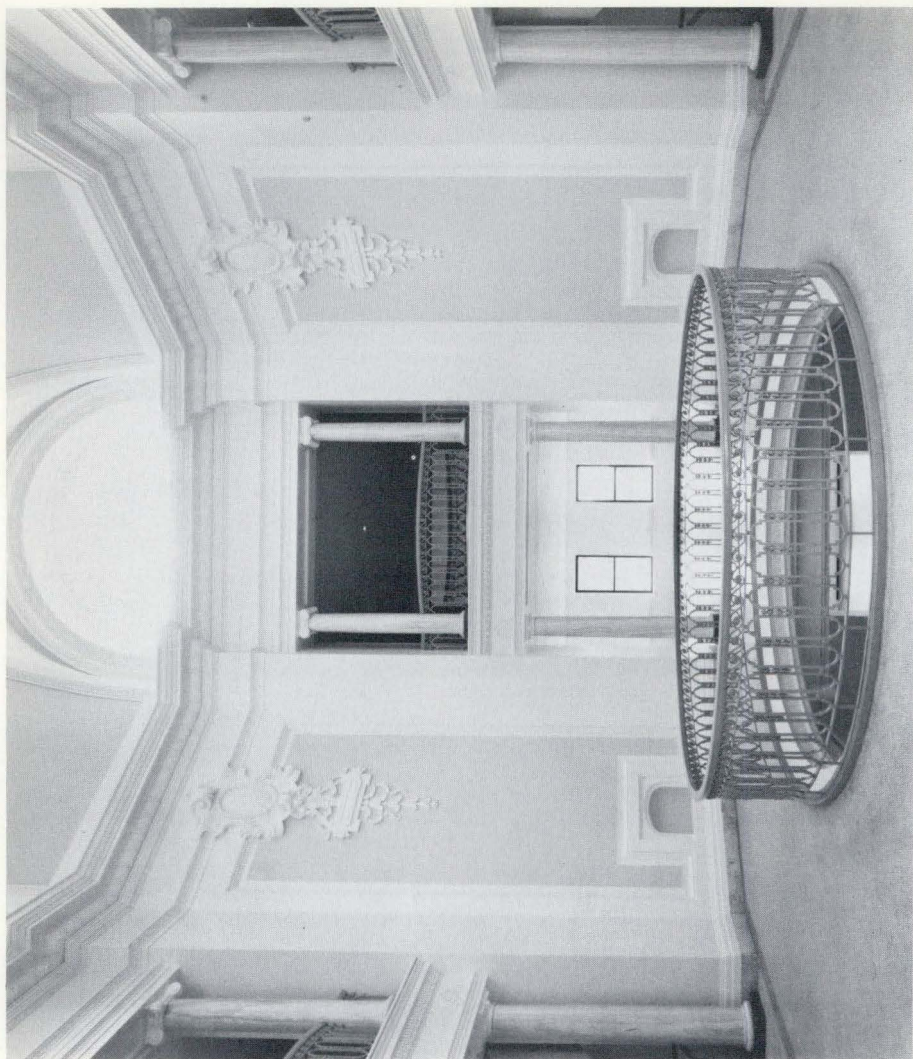
In the Old Courthouse, visitors gained access to the upper storeys via stairs set in one of the corridors near the central well. Now one ascends on elegant escalators on either side of the Rotunda. Several photographs document the difficult processes involved in the Rotunda's reconstruction.

In this new Rotunda, a grand staircase was created in what had formerly been a storage room. The half arches it contained have been painstakingly recreated as whole ones. Worn marble stair treads, taken from another part of the building, are set in the concrete structure of the contemporary steps that lead to the upper levels. This staircase is fitted with balustrades modelled on those which decorate the balconies of the upper levels.
