Riverbank Change Detection and Impact of Water Level Rise along Mekong River in Nong Khai Province of Northeast Thailand using Geo-Informatics Approach

Suwanlertcharoen, T.1 and Pongput, K.2

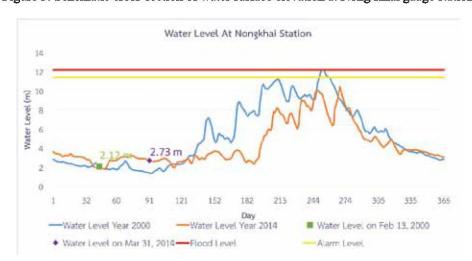
Figure 4: Mekong River water level at Nong Khai gauge station year 2000 and 2014 on the date of satellite imagery analysis

By monitoring and comparing water level data of the Mekong River at Nong Khai station by Department of Water Resources the same date of LANDSAT-7 imagery recorded in 2 0 0 0, twelve years prior to the construction of Xayaburi Dam on the lower Mekong River in northern Lao PDR and LANDSAT-8 imagery recorded in 2014, two years after the Dam was constructed as details shown in Table 2 below. According to the study, water levels of the Mekong River at Nong Khai gauge station in Nong Khai province on February 13, 2000 reached 2.12 meters while reached 2.73 meters on March 31, 2014. The water level on the analysis date of the year 2014 was higher than of the year 2000 at 0.61 meters as shown in Figure 4. During the dry season from December to April, the water level at Nong Khai gauge station in 2014 was higher than in 2000 in the same period of time also higher than the average water level over the 1967-2014 period as

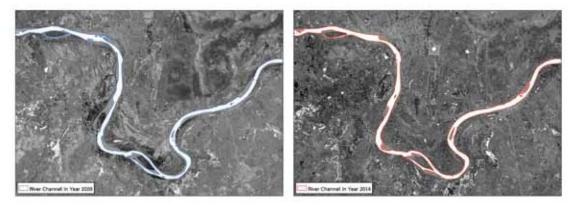
Figure 5: Mekong River channel extracted from NDWI in 2000 and 2014

The Mekong River channel was extracted from LANDSAT satellite images recorded in the year 2000 and 2014 using threshold technique on NDWI values to classify land and river channel then produced in GIS file format as shown in Figure 5. In this study, a threshold value of 0.52 was applied to extract the river channel the from NDWI image captured by LANDSAT year 2000 and value of 0.12 for 2014 respectively.
