# GIS-Based Landslide Susceptibility Map Verification by its Geotechnical and Geological Characteristics

Herianto, P.,\* Kunsuwan, B., Mairaing, W., Chalernpornchai, T. and Srisook, W.,

Division of Geotechnical Engineering, Department of Civil Engineering, Faculty of Engineering at Kamphaeng Saen, Kasetsart University, Kamphaeng Saen Campus, Thailand, E-mail: putra.h@ku.th

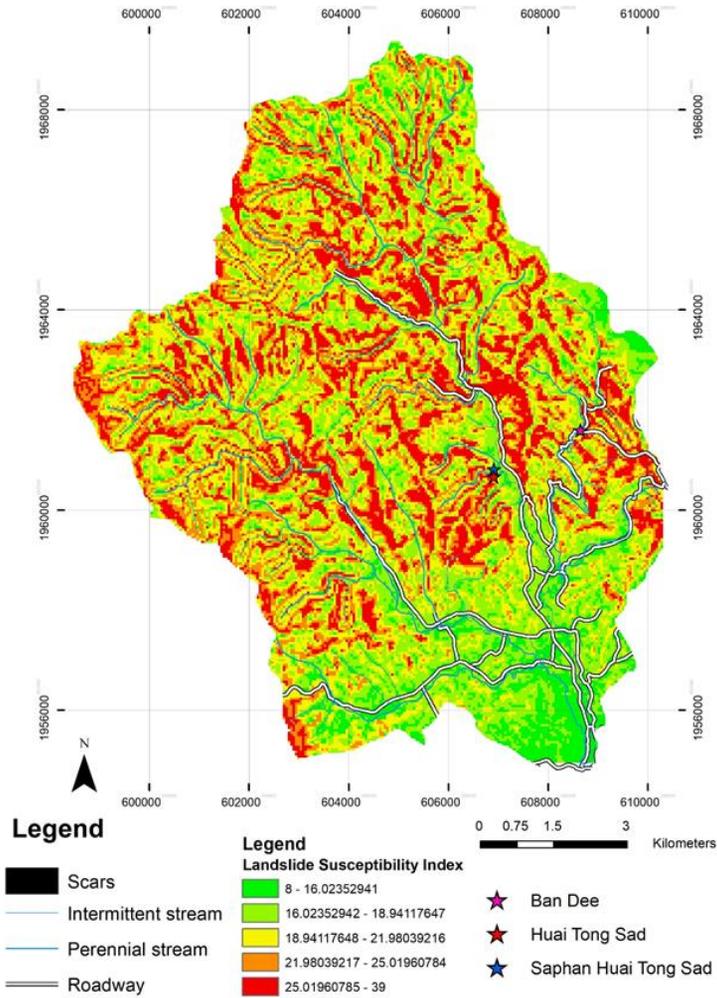
Figure 3: Landslide susceptibility index map of Mae Phun, Uttaradit, Thailand (Herianto, 2020)

Herianto (2020) mentioned that they used the frequency ratio method in order to make the landslide susceptibility map, which has a range accuracy of the map from 49 to 89%. However, this accuracy verification was done by using area under curve and receiver operating characteristics curve, a statistical approach. Commonly, engineers prefer to validate further by using field and laboratory measurements to know whether the map that has been created is accurate enough based on physical field data. Herianto (2020) divided the landslide susceptibility map of Laplae area into five main landslide susceptibility index (LSI), as shown in Figure 3. The lower value of the LSI, meaning the lower probably a landslide will occur, while the higher the value of the LSI, meaning the higher probably a landslide will occur. Those five classes were subjectively renamed as very low susceptibility, low susceptibility, medium susceptibility, high susceptibility, and very high susceptibility.

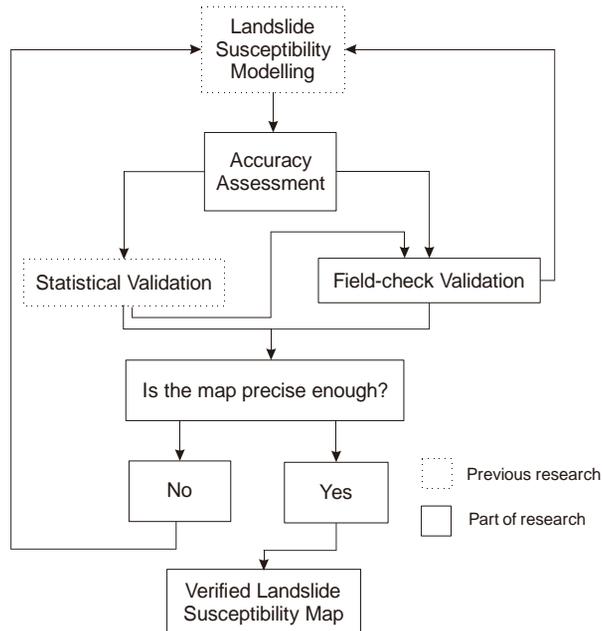
Figure 4: Methodology for landslide susceptibility mapping

However, the susceptibility maps formed was verified using only existing landslide location (scar data) by a statistical approach. In order to better understand and to verify the status of the landslide susceptibility map in the field, direct field and laboratory approaches will be done accordingly. The direct validation not only is important for increasing the susceptibility map precision, but its data can also be used for future landslide susceptibility modeling as input data, as shown in the flowchart of

methodology in Figure 4. This study not only evaluates and compares the geotechnical properties and geology of landslide locations but also works as an engineering verification of a landslide status in the GIS-based landslide susceptibility mapping of the area (Herianto, 2020) between the past location of landslides and landslide-free (or commonly called as non-landslide) location. Moreover, in order to compare and to evaluate these parameters on landslides, the properties of the soils that cover slopes are measured, and the geological conditions are investigated.

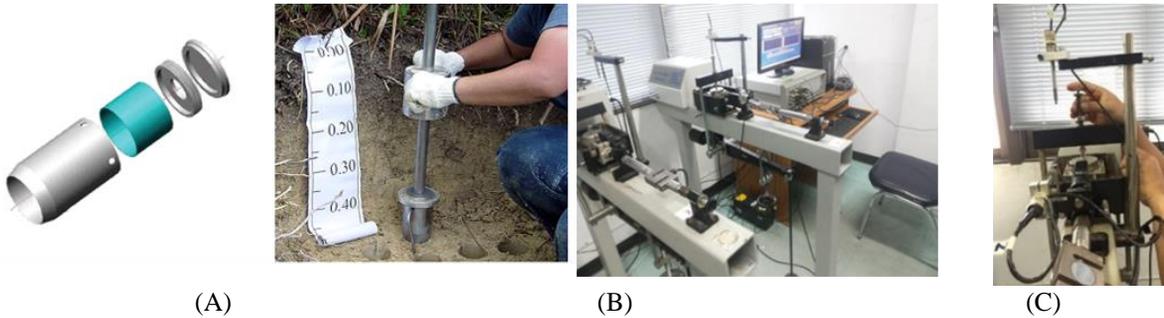
(A) KU-miniature instrument (Mairaing, Thaijeamaree, & Kulsuwan, 2005), (B) the complete instruments of the direct shear test, and (C) the direct shear box equipment

Field surveys entailed mapping the Laplae area using software such as Rockd (Wisconsin-Madison, 2019) and SuperSurv (Inc., 2019). A total of three sites was undertaken using a geological compass and a tape measure. At each point, pits were dug to a depth of 100 cm. Undisturbed soil samples were obtained at different depths (generally at an interval of 30 cm) using KU-miniature sampler, while disturbed soil samples were obtained at different depths of 30 cm also by using shovels. These samples were kept in air-tight-zipped plastic bags. Undisturbed soil samples were collected by using KU- miniature thin-wall sampler, developed by Kasetsart University (Mairaing et al., 2005), as shown in Figure 5a. These soil samples were used for the determination of cohesion and angle of internal friction under normal loading by conducting a multi-stage direct shear test in a consolidated drained test.

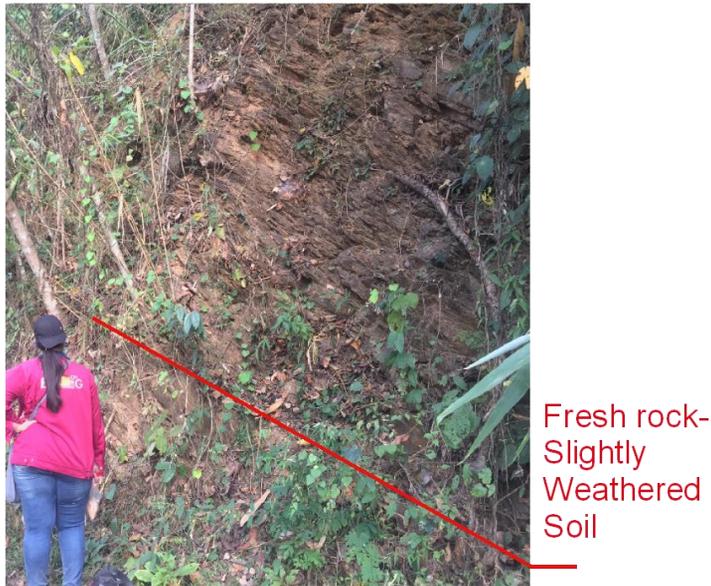
Figure 6: An Outcrop in BD area

The thickness of the outcrop in Figure 6 is approximately 3 meters. The color of the soils from chert is dark brownish-red. The grain size particle is  $<1/16 \text{ mm}$ , amorphous, layering structure, strike/dip  $N16^0E/55^0$ , mono-mineral silicas 100%, very low porosity. Total thickness is more than 5 meters. The thickness of the carbonaceous siltstone outcrop in Figure 7 is approximately 2 meters. The color of the soils of siltstone is brownish-red. The grain size particle is between  $1/256 \text{ mm}$  to  $>64 \text{ mm}$ , poorly sorted, sub-angular, matrix-supported. Lithic fragments consist of sandstone: whitish color, well-

sorted,  $1/4 - 2 \text{ mm}$ , consist of 50% K-feldspar, 20% Ca/Na-Feldspar, 10% micas, 5% quartz and carbonates cement of 15%, massive, good porosity. Total thickness is more than 3 meters. The thickness of the carbonaceous sandstone outcrop in Figure 8 is approximately 5 meters. The color of the soils of sandstone is brownish-white. The grain size particle is between  $<1/16 \text{ mm}$  to  $2 \text{ mm}$ , well-sorted, sub-rounded, grain-supported. Lithic fragments consist of sandstone: whitish color, well-sorted,  $1/4 - 2 \text{ mm}$ , consist of 60% Ca/Na-feldspar, 20% K-Feldspar, 10% micas, 5% quartz and carbonates cement of 5%, massive, good porosity. Total thickness is more than 5 meters.

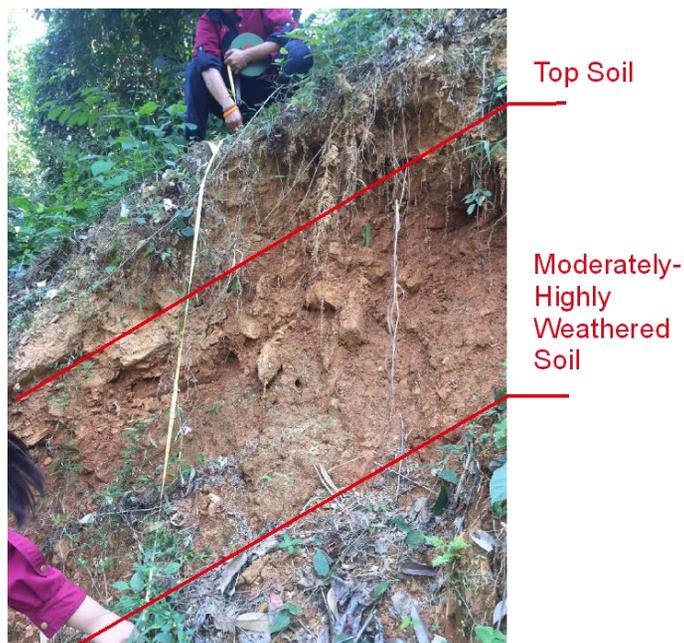
Figure 7: An Outcrop in HTS Area

The results from the field observations showed that, at the HTS landslide site, a translational debris flow had occurred. Evidence from past scars at the HTS site indicated an intermixture of materials between deeper depth materials and shallower materials. The SHTS site, however, was the non-landslide location. A further remote sensing analysis was also accomplished in order to verify landslide scars location by using a 15 m DEM, satellite image, and previous researchers' mapping results (Herianto, 2020 and Khositanont et al., 2016). The landslides were found to have occurred mostly on concave slopes ranging between 30-40 slope angles. The average depth of landslide is 2.3 meters, and the average depth of slip is 3 meters. The percentage of landslides that occurred in the meta-shale unit is 35.44%, while 64.56% happened in the meta-greywacke unit. Field measurements revealed that the compressive strength and the shear strength of the BD site, HTS site, and SHTS site, respectively, are 539 kPa and 54 kPa; 294 kPa and 44 kPa; 490 kPa and 49 kPa. It agrees with other researchers' results that the landslide area is having lower compressive strength and shear strength than the non-landslide area (Carruba and Moraci, 1993, Iannacchione and Vallejo, 2000 and Szafarczyk, 2019). The location has elevation ranges from 100 to 500 meters above sea level. The geomorphology of the sites is moderate-highly dissected denudational hills. The main lithology of the outcrops in location mostly consists of chert, siltstone, and sandstone.

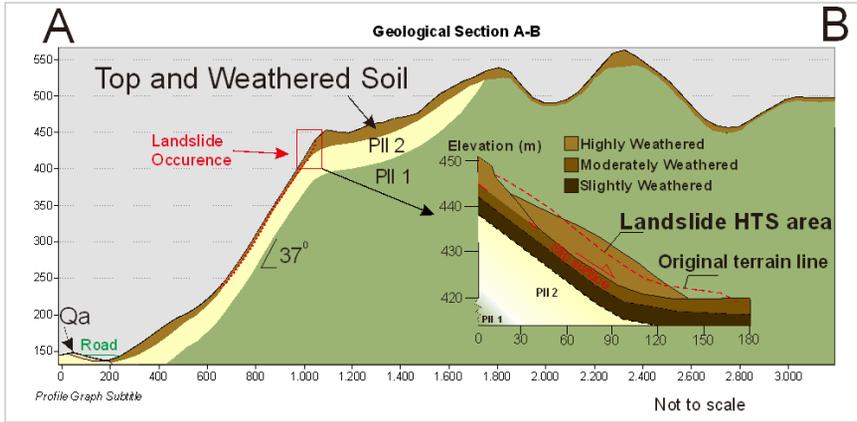
Figure 13: Geological section of laplae, Uttaradit, Thailand

The geological map and the geological section of the research location is shown in Figure 12 and Figure 13, respectively. The units of geology in the location are divided into three different units. The oldest unit, which is part of PII1, is consisted of siltstone, in some places interbedded with sandstone and chert.

This unit is in green color on the map, which is called as Siltstone Interbedded with Sandstone and Chert Unit. The younger unit, which is part of PII2, is consisted of sandstone interbedded with chert. This unit is in yellow color on the map, which is called as Sandstone Interbedded with Chert Unit. The last unit, which is part of Qa, is consisted of alluvial deposits. This unit is in orange color on the map, which is called as Alluvial Deposits Unit.

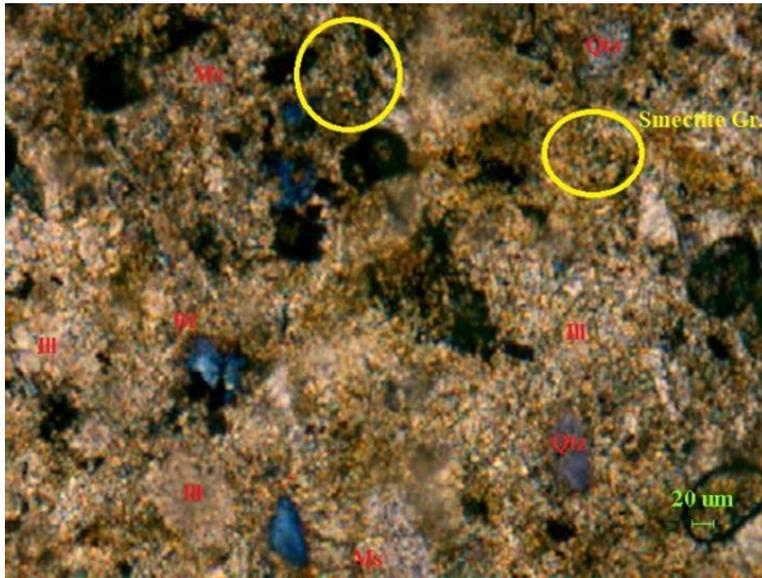
Figure 14: Shale thin section in the BD site under the normal-light microscope

The results show that the highest mineral composition percentage in each site is different. Smectite is found to be the most abundant mineral in HTS site, as shown in Figure 15, while in BD and SHTS, as shown in Figure 14 and Figure 16, Illite is the most dominant mineral, as shown in Table 1. The result was also verified by the Department of Mineral Resources of Kingdom of Thailand which its laboratory analysis results show that the rocks found in BD, HTS, and SHTS sites are classified, respectively, as shale, siltstone, and sandstone.

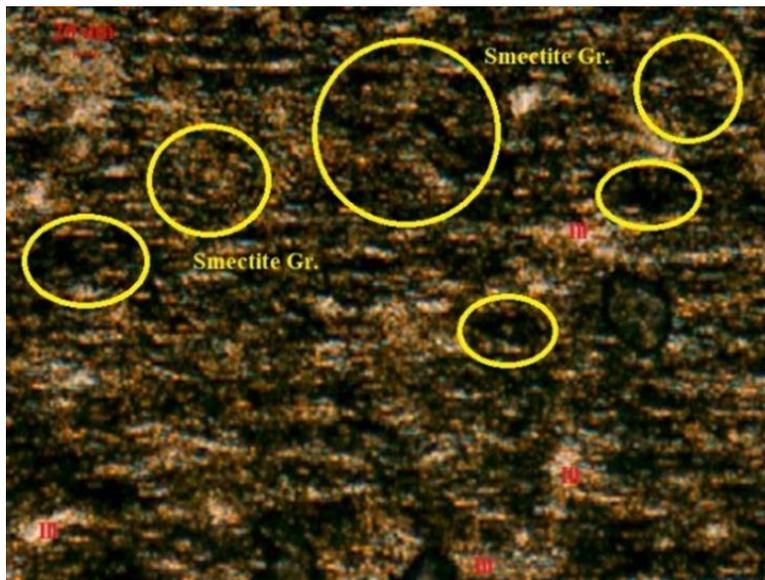
Figure 15: Siltstone thin section in the HTS site under the normal-light microscope

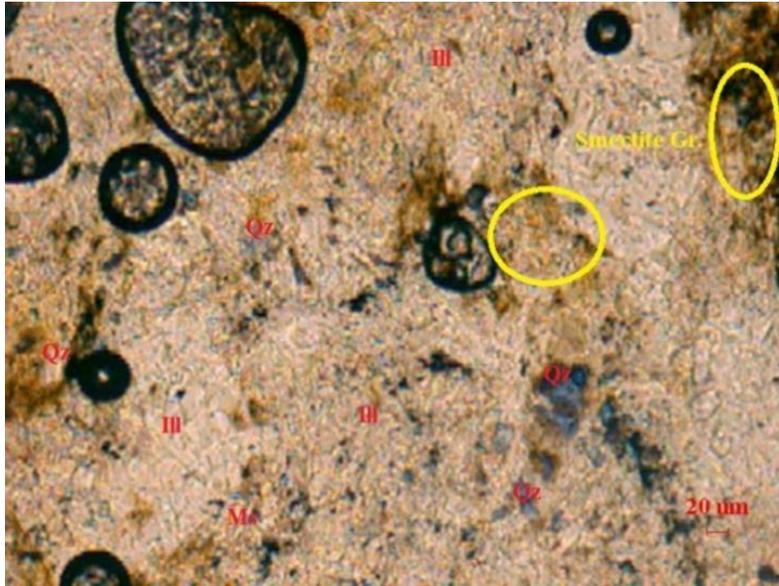
Figure 16: Sandstone thin section in the SHTS site under the normal-light microscope

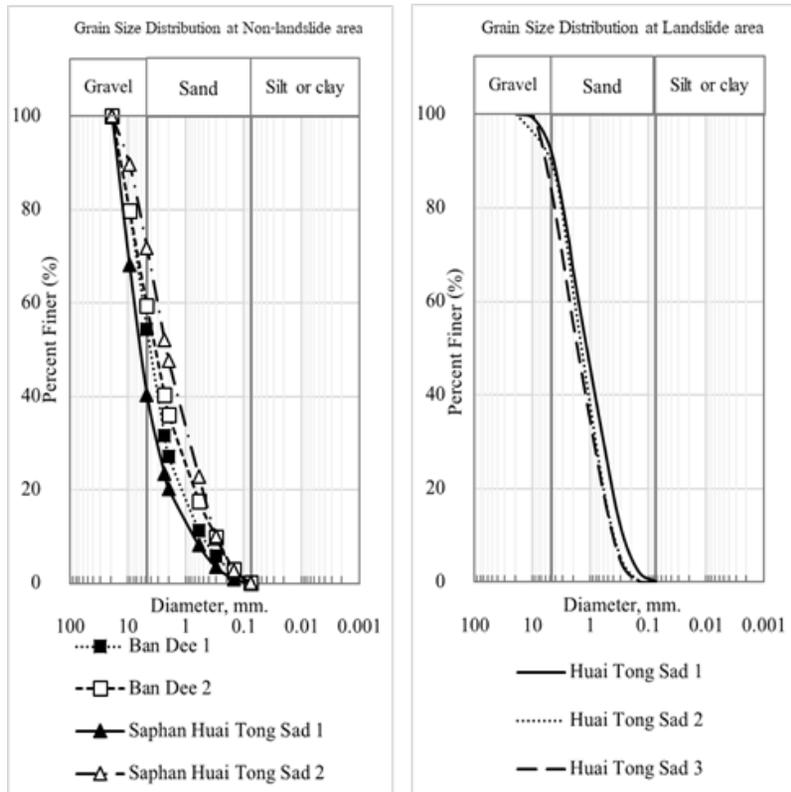
Figure 17: Particle distribution curve in the area

Particle distribution curves are shown in Figure 17. Soils from the respective sites were generally coarse-grained, with less than 50% of the material passing the 0.075 mm sieve.  $D_{60}$ ,  $D_{30}$  and  $D_{10}$  of the BD, HTS, and SHTS sites, respectively, are 5.50 mm, 2.00 mm, 0.40 mm; 2.00 mm, 0.80 mm, 0.40 mm; and 5.00 mm, 1.50 mm, 0.50 mm. Soils from the HTS site are finer and more poorly graded than those from the other two sites. The finer soil means that the angle of internal friction and the peak friction angle is lower, which leads to a weaker strength of soil which characterized the landslide area, as confirmed with other researchers' results

(Casini et al., 2011, Iannacchione and Vallejo, 2000, Islam et al., 2011, Mostefa et al., 2013 and Stark et al., 2014). Specifically, soils from BD site are greyish-brown gravelly sand, classified as well-graded sand with little fines material (SW), while HTS soils are reddish-brown silty sand, classified as poorly graded sand with little fines material (SP) groups. The soils from SHTS are yellowish-brown gravelly sand, classified as well-graded sand with little fines material (SW) groups.

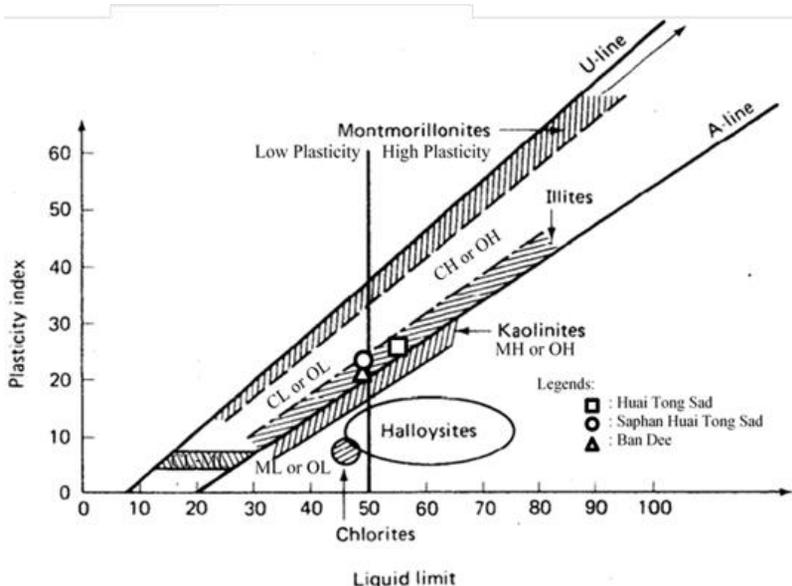
Figure 18: Casagrande plasticity chart of the site location (Modified from Holtz and Kovacs (1981))

Soil moisture and Atterberg limits, as shown in Table 1, were measured and calculated for the behavior of soils in response to water content, and the following implications for landslide occurrence. Even though the soils are coarse-grained material, the Atterberg limits are calculated in order to analyze the behavior of the matrix-grained parts of the soil. The HTS soil has the highest soil moisture value. The liquid limit of HTS is above the threshold of 50% (ASTM, 2017a). It means that the HTS clay has high swelling potential of the clay materials. The PI of HTS site also shows the highest expansion potential of the clay materials among other sites as well, it is considered as high plasticity clays. This means that the nature of the soils might be one of the inherent factors. The plasticity chart, which including PI that highlights the range of water contents where the soil exhibits plastic properties, is shown in Figure 18. The plasticity chart shows that even though all the soils of the non-landslide area is critically near the 50% boundary of low and high plasticity, the only soil that contains high plasticity clay is located at HTS site. This confirms that the high plasticity of soils represents the characteristics of the landslide area as in accordance with others' results (Bizimana and Sönmez, 2015, Kitutu et al., 2009 and Soralump, 2008). The nature of highly plastic soil of HTS site is displayed by their plotting above the boundary A-line and their PI is exceeded the B-line threshold of 50%.

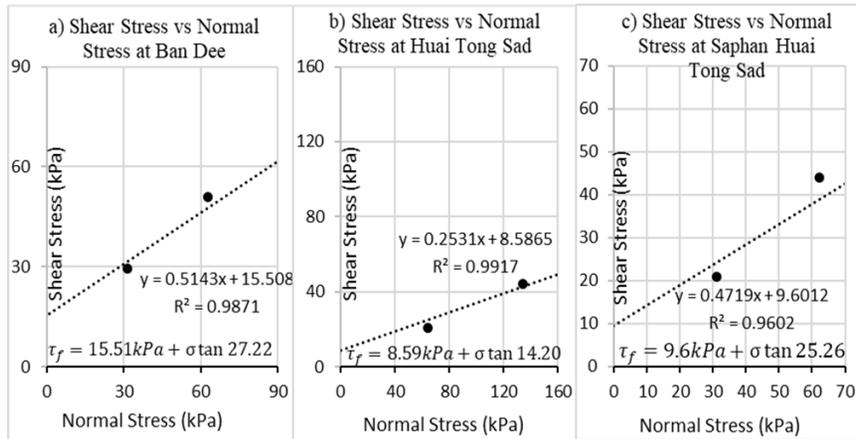
Figure 19: Shear stress versus normal stress curves for BD, HTS, and SHTS sites

The angle of internal friction and cohesion were computed by plotting shear strength versus normal stress curves, which were then used to calculate the Factor of Safety for each site. BD, HTS, and SHTS sites' curves are shown, respectively, in Figure 19(a,b,c). The number of points of scars vs. slope in the research area is shown in Figure 20. The landslides dominantly occurred in  $30^{\circ}$ - $40^{\circ}$  slope, with a mean of  $33.8^{\circ}$ .

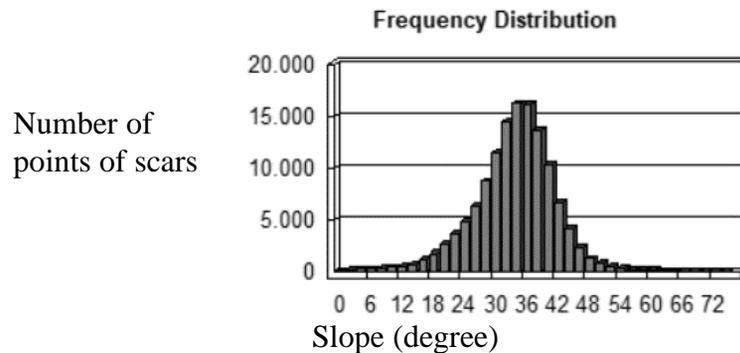
Figure 20: Frequency of landslide scars with various slope angle

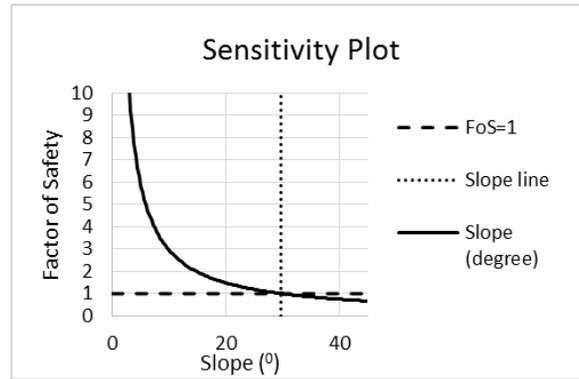
Figure 21: Sensitivity for slope

It needs to be noted that even slopes where  $F_s > 1$  is conditionally stable, the external and internal factors may change its stability when it applies their influence on landslides such as rainfall intensity rises, and the shrink-swell capacity of the clays triggered. These results also agree with other researchers' results, which show that translational failure mechanisms generally occurred at slopes with angles between  $8^\circ$  to  $32^\circ$  (Schilter, 2019), between  $30^\circ$  to  $45^\circ$  (Huang et al., 2016), more than  $25^\circ$  (Zêzere, 2002). Sensitivity analysis assists researchers to evaluate the impact of an individual unknown variable, with the assumption that all other slope parameters are known. In this analysis, one

parameter varies, and other input parameters are kept constant in their mean values. The analysis assesses of which input parameter may be more critical to the assessment of the slope stability, and vice versa, which parameter has less effect on the instability. The cohesion and friction angle of the failure surface was back analyzed by performing a sensitivity analysis. The effects of slope, cohesion, and angle of internal friction to the factor of safety are presented in the form of sensitivity graphs in Figure 21, Figure 22, and Figure 23 in which the vertical axis represents the factor of safety and the horizontal axis represents the slope or cohesion or angle of internal friction.

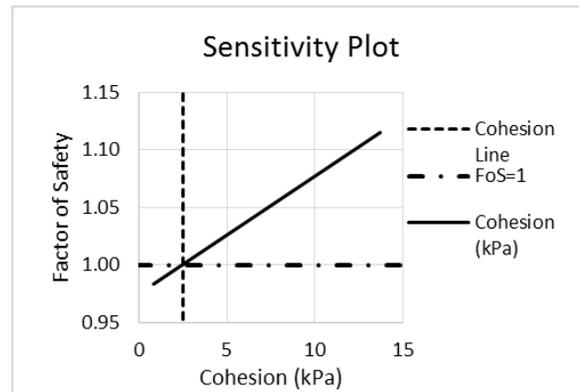
Figure 22: Sensitivity graph of cohesion

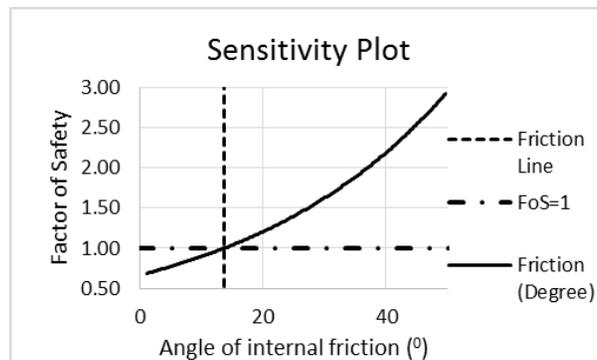
Figure 23: Sensitivity for friction angle

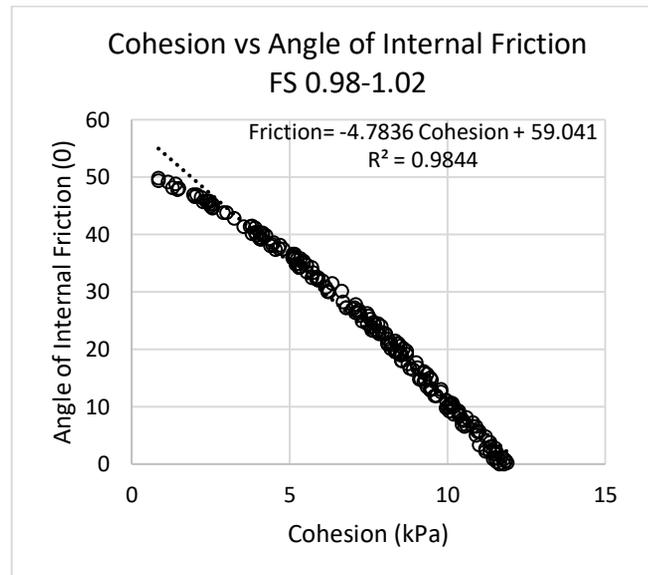
Figure 24: The relationship between cohesion and friction angle of the rock mass for an approximate factor of safety of 1, the dotted line is the line of factor of safety = 1

The value of cohesion and angle of internal friction by using the back analysis is compared with the value of cohesion and angle of internal friction obtained from the laboratory. The slope, cohesion, and the angle of internal friction obtained in the laboratory of the HTS site, where a landslide did occur in 2006, is  $30^{\circ}$ , 8.59 kPa and  $14.2^{\circ}$ , respectively. On the other hand, from the back-analysis result, it is indicated that at the edge of failure, i.e., a factor of safety of 1, the slope, cohesion, and friction angle values were  $29.63^{\circ}$ , 2.51 kPa and  $13.70^{\circ}$ , respectively. The relationship of cohesion and angle of internal friction from the back analysis is shown in Figure 24.
