UAV Survey for Landslide Hazard Assessment in the Former Min-Kush Uranium Processing Site

Abstract

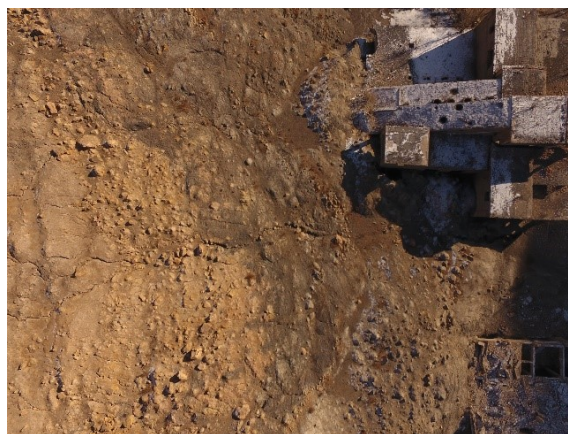
- The photographic acquisition at the study area was performed according to the UAV flight plan at a flying height of about 90 m above ground level, achieving a mean ground sampling distance (GSD) of about 2 cm/px (Figure 3).
- Survey data processing.

Figure 3: UAV photography of the PP-2013 landslide

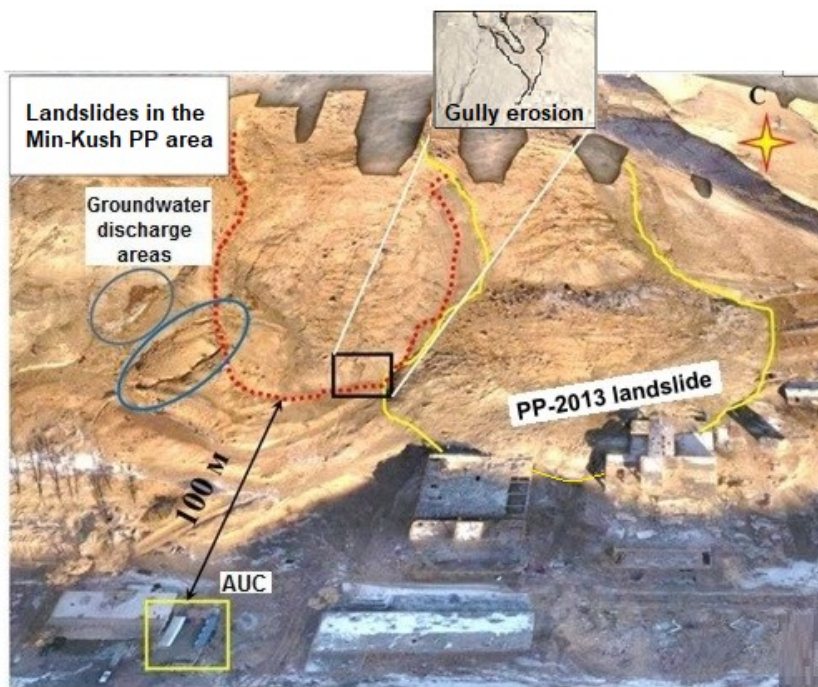
Figure 5: Landslide situation on the slope above the Min-Kush PP: UAV photography based 3D image of the slope and PP-2013 landslide (yellow outline); red dotted outline - the zone of active deformations of a new potentially dangerous landslide with a threat to the AUC; the gully areas are shown in the lower part of the dump in the black rectangle

One of the obtained three-dimensional images is presented in Figure 5, in which the deformation zone is highlighted with a red dotted line, which can become the head part of another landslide on the considered slope. The western flank of the deformation zone of groundwater outcrops, as well as gullies, shown in the blue ovals. Due to negative air temperatures at the time of shooting, a piece of ice is formed in the place where the water wedged out.

At present, in the deformation zone, the process of preparing the slope for the main displacement towards the Administrative and Utility Containers (AUC) is developing, which can occur with a combination of high moisture content of the rocks in the deformation zone in spring and a strong earthquake within a radius of up to 100 km from Min-Kush. It should be noted that after the descent of the landslide from the deformation zone, a significant volume of rocks located above it may be mobilized. In Figure 4, the outlines of this zone are shown with a black dashed line.

- Transfer of the Administrative and Utility Containers (AUC) from a potentially hazardous landslide affected area to a safe location. Organization of the landslide- monitoring by applying a geodetic method with totalstations at several benchmarks (combined with GCPs) fixed along the profile in the North-South direction. It is advisable to install the total station at the permanent reference point to control the displacement of the fixed benchmarks on the

- Installation and satellite positioning of the permanent GCPs on the PP-2013 landslide for the regular UAV survey for monitoring.
- Installation of the contemporary motion sensors.

Moving containers to a safe area seems to be the most reliable measure to prevent the death and injury of workers. Regular geodetic monitoring of the deformation zone will allow early detection of the precursors of slope collapse and thereby introduce an appropriate level of advance warning on the principle of a traffic light, when at the yellow level of alarm it is possible to envisage restricting the access of personnel, vehicles and mechanisms to a potentially dangerous zone of landslide damage. At the red alarm level, the complete prohibition of the stay of people and construction equipment on the territory of the former processing plant.
